Flood Control Project Maintenance
2020 Structure Summary Report
Overall Unit and Item Ratings

Reclamation District No. 2063 Crows Landing

Lateral No. 6 Pumping Plant

Pumping Plant Rating	A
Date of Inspection	6/24/2020
DWR Inspector	Corey Fujitani
Accompanied By	Joe Sallaberry RD2063

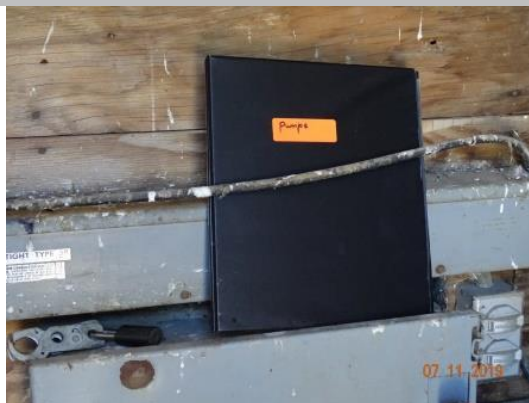
Photo 1 of 1 : ST_2020_RD2063_53_1_20200610_00001.jpg

LM Start	0.00	Rating **	A	Issue No.	1
LM End	0.00	Issue Type +	Ma	Location *	
Category	Pump Stations			GPS Latitude/Longitude	
				Start	End
Item	Operating Log			37.397931 °	37.397931 °
				-120.972176 °	-120.972176 °
DWR ID	DWR_RD2063_53_t_2012_1				
Action/Comments					
Inspector Comments: Operation log is present at the pumping plant.

View of log inside the pump house. (2019)

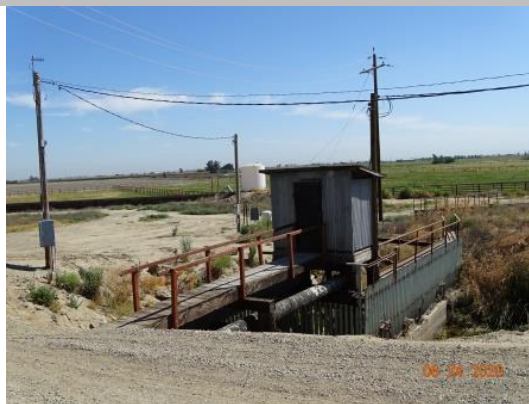
Photo 1 of 2 : ST_2020_RD2063_53_4_20200625_00019.jpg

LM Start	0.00	Rating **	A	Issue No.	4
LM End	0.00	Issue Type +	Ma	Location *	
Category	Pump Stations			GPS Latitude/Longitude	
				Start	End
Item	Plant Building			37.397931 °	37.397931 °
				-120.972176 °	-120.972176 °
DWR ID	DWR_RD2063_53_t_2012_4				
Action/Comments					
Inspector Comments: The plant building appeared to be in a good structural condition. Screens have been placed around the pumphouse to keep out nesting birds.

Overview of the pumphouse. (2020)

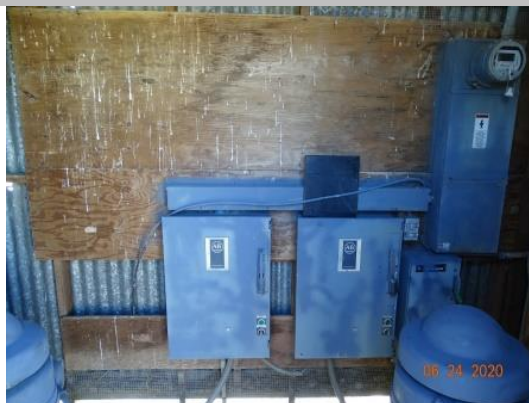
Photo 2 of 2 : ST_2020_RD2063_53_4_20200625_00020.jpg

LM Start	0.00	Rating **	A	Issue No.	4 (cont)	
LM End	0.00	Issue Type +	Ma	Location *		
Category	Pump Stations			GPS Latitude/Longitude		
				Start		End
Item	Plant Building			37.397931 °		37.397931 °
				-120.972176 °		-120.972176 °
DWR ID	DWR_RD2063_53_t_2012_4					
Action/Comments						
Inspector Comments: The plant building appeared to be in a good structural condition. Screens have been placed around the pumphouse to keep out nesting birds.

View of the pumping plant interior. (2020)

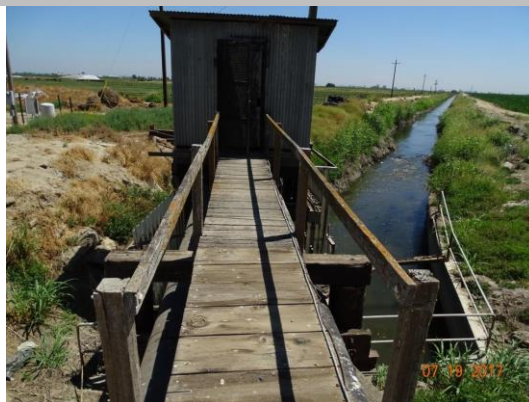
Photo 1 of 1 : ST_2020_RD2063_53_6_20200610_00004.jpg

LM Start	0.00	Rating **	A	Issue No.	6	
LM End	0.00	Issue Type +	Ma	Location *		
Category	Pump Stations			GPS Latitude/Longitude		
				Start	End	
Item	Safety			37.397931 °	37.397931 °	
				-120.972176 °	-120.972176 °	
DWR ID	DWR_RD2063_53_t_2012_6					
Action/Comments						
Inspector Comments: No safety issues identified at the pumping plant.

View of the handrails.

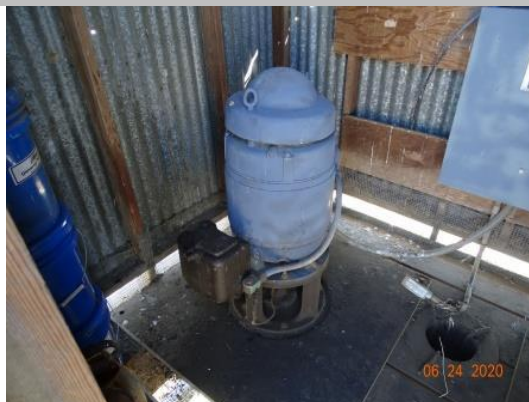
Photo 1 of 2 : ST_2020_RD2063_53_7_20200625_00021.jpg

LM Start	0.00	Rating **	A	Issue No.	7	
LM End	0.00	Issue Type +	Ma	Location *		
Category	Pump Stations			GPS Latitude/Longitude		
				Start	End	
Item	Pumps			37.397931 °	37.397931 °	
				-120.972176 °	-120.972176 °	
DWR ID	DWR_RD2063_53_t_2013_7					
Action/Comments						
Inspector Comments: Pumps appeared to be well maintained and functional.

View of one of the pumps inside the plant. (2020)

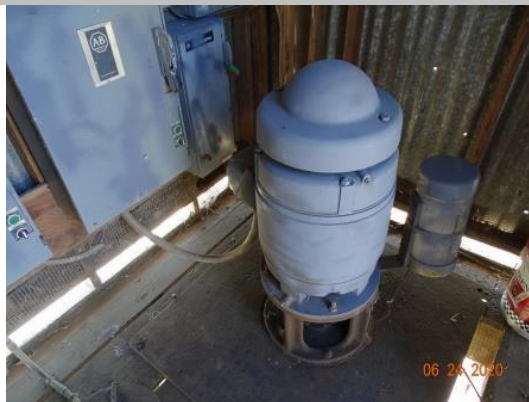
Photo 2 of 2 : ST_2020_RD2063_53_7_20200625_00022.jpg

View of the second pump inside the plant. (2020)

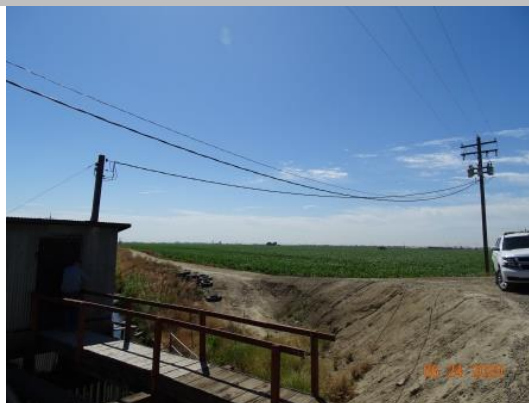
Photo 1 of 1 : ST_2020_RD2063_53_9_20200625_00023.jpg

LM Start	0.00	Rating **	A	Issue No.	9
LM End	0.00	Issue Type +	Ma	Location *	
Category	Pump Stations			GPS Latitude/Longitude	
				Start	End
Item	Power			37.397931 °	37.397931 °
				-120.972176 °	-120.972176 °
DWR ID	DWR_RD2063_53_t_2013_9				
Action/Comments					
Inspector Comments: The power source appeared to be safe and adequate.

View of the power source for the pumping plant. (2020)

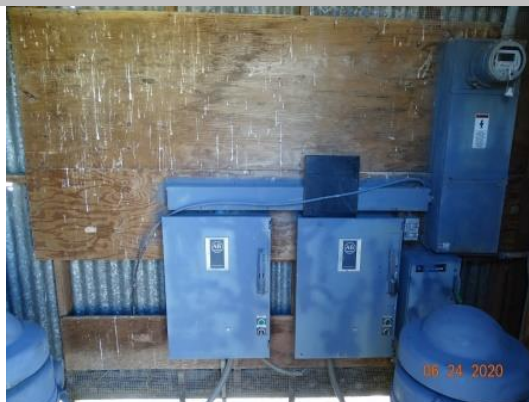
Photo 1 of 1 : ST_2020_RD2063_53_10_20200625_00024.jpg

LM Start	0.00	Rating **	A	Issue No.	10
LM End	0.00	Issue Type +	Ma	Location *	
Category	Pump Stations			GPS Latitude/Longitude	
				Start	End
Item	Pump Control Systems			37.397931 °	37.397931 °
				-120.972176 °	-120.972176 °
DWR ID	DWR_RD2063_53_t_2012_10				
Action/Comments					
Inspector Comments: Pump control systems were operational.

View of power meter and pump control system. (2020)

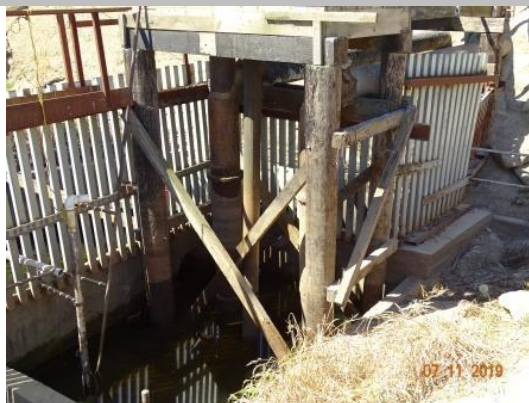
Photo 1 of 1 : ST_2020_RD2063_53_12_20200610_00010.jpg

LM Start	0.00	Rating **	A	Issue No.	12
LM End	0.00	Issue Type +	Ma	Location *	
Category	Pump Stations			GPS Latitude/Longitude	
				Start	End
Item	Sumps/Wet Well			37.397931 °	37.397931 °
				-120.972176 °	-120.972176 °
DWR ID	DWR_RD2063_53_t_2012_12				
Action/Comments					
Inspector Comments: The sump well was free of debris.

View of sump well. (2019)

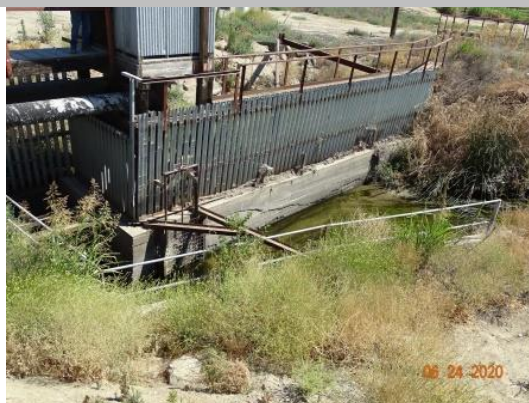
Photo 1 of 1 : ST_2020_RD2063_53_13_20200626_00025.jpg

LM Start	0.00	Rating **	A	Issue No.	13
LM End	0.00	Issue Type +	Ma	Location *	
Category	Pump Stations			GPS Latitude/Longitude	
				Start	End
Item	Trash Racks			37.397931 °	37.397931 °
				-120.972176 °	-120.972176 °
DWR ID	DWR_RD2063_53_t_2012_13				
Action/Comments					
Inspector Comments: The trash racks appears to be in good working condition.

View of trash racks. (2020)

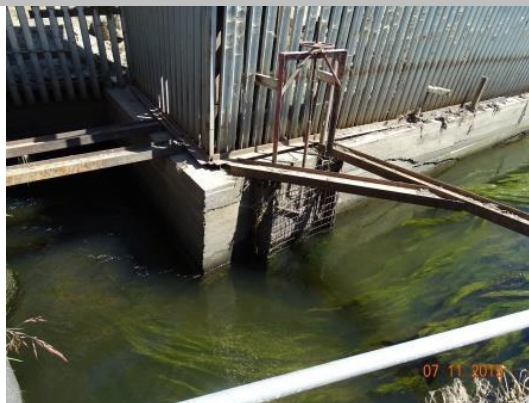
Photo 1 of 1 : ST_2020_RD2063_53_11_20200610_00009.jpg

LM Start	0.00	Rating **	A	Issue No.	11
LM End	0.00	Issue Type +	Ma	Location *	
Category	Pump Stations			GPS Latitude/Longitude	
				Start	End
Item	Sluice / Slide Gates			37.397931 °	37.397931 °
				-120.972176 °	-120.972176 °
DWR ID	DWR_RD2063_53_t_2012_11				
Action/Comments					
Inspector Comments: The slide gate appeared to be in working condition.

View of slide gate to sump well. (2019)

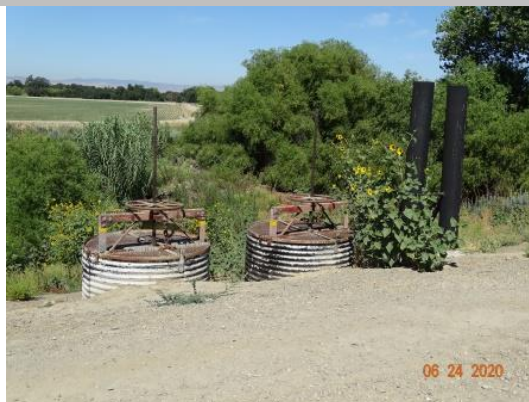
Photo 1 of 1 : ST_2020_RD2063_53_17_20200626_00029.jpg

LM Start	0.00	Rating **	A	Issue No.	17
LM End	0.00	Issue Type +	Ma	Location *	
Category	Pump Stations			GPS Latitude/Longitude	
				Start	End
Item	Manual Gate Operators			37.397931 °	37.397931 °
				-120.972176 °	-120.972176 °
DWR ID	DWR_RD2063_53_t_2012_17				
Action/Comments					
Inspector Comments: The manual gate operators were lubricated and in good working condition.

View of manual gate operators. (2020)

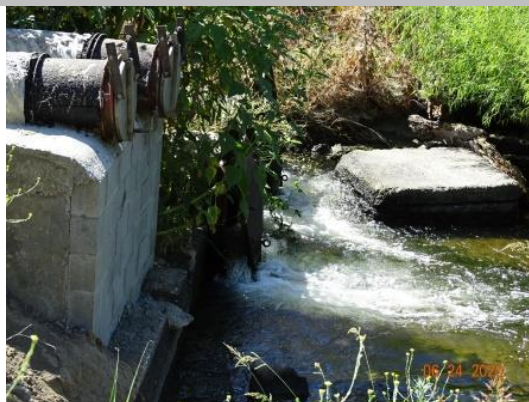
Photo 1 of 3 : ST_2020_RD2063_53_16_20200626_00027.jpg

LM Start	0.00	Rating **	A	Issue No.	16
LM End	0.00	Issue Type +	Ma	Location *	
Category	Pump Stations			GPS Latitude/Longitude	
				Start	End
Item	Flap Gates			37.397931 °	37.397931 °
				-120.972176 °	-120.972176 °
DWR ID	DWR_RD2063_53_t_2013_16				
Action/Comments					
Inspector Comments: Flap gates appeared to be in a good working condition.

View of the flap gates. (2020)

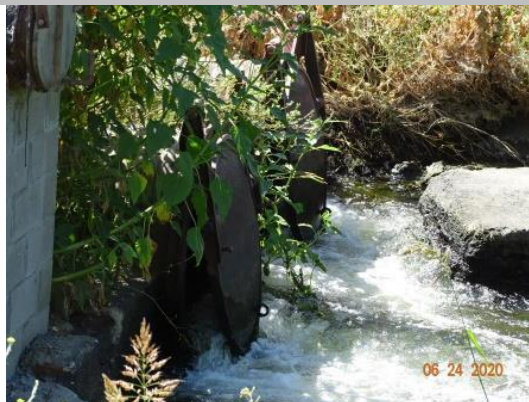
Photo 2 of 3 : ST_2020_RD2063_53_16_20200626_00028.jpg

View of the flap gates. (2020)

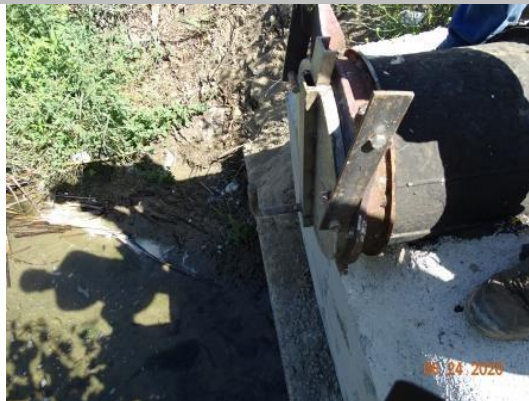
Photo 3 of 3 : ST_2020_RD2063_53_16_20200626_00026.jpg

LM Start	0.00	Rating **	A	Issue No.	16 (cont)	
LM End	0.00	Issue Type +	Ma	Location *		
Category	Pump Stations			GPS Latitude/Longitude		
				Start		End
Item	Flap Gates			37.397931 °	37.397931 °	
				-120.972176 °	-120.972176 °	
DWR ID	DWR_RD2063_53_t_2013_16					
Action/Comments						
Inspector Comments: Flap gates appeared to be in a good working condition.

View of the pump outlet flap gates.

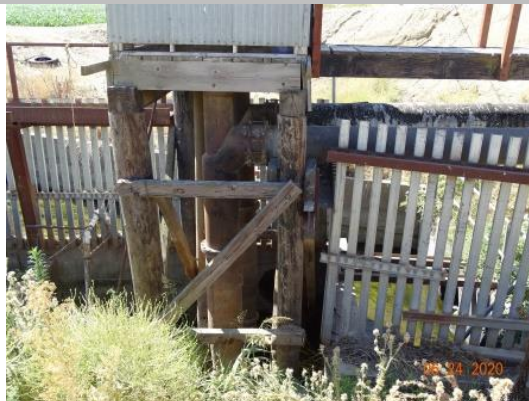
Photo 1 of 2 : ST_2020_RD2063_53_20_20200626_00030.jpg

LM Start	0.00	Rating **	A	Issue No.	20
LM End	0.00	Issue Type +	Ma	Location *	
Category	Pump Stations			GPS Latitude/Longitude	
				Start	End
Item	Intake and Discharge Pipes			37.397931 °	37.397931 °
				-120.972176 °	-120.972176 °
DWR ID	DWR_RD2063_53_t_2013_20				
Action/Comments					
Inspector Comments: The intake and discharge pipes appeared to be in good condition.

View of intake pipes. (2020)

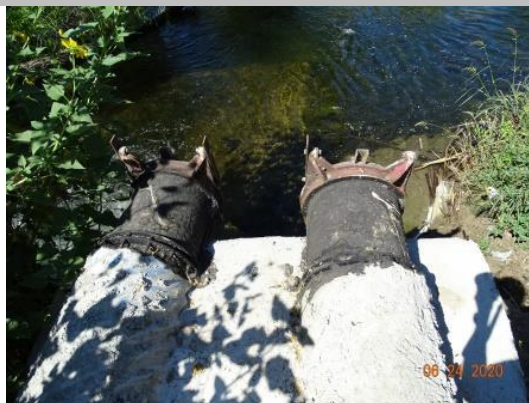
Photo 2 of 2 : ST_2020_RD2063_53_20_20200626_00031.jpg

View of outlet pipes. (2020)
